# PROFESSIONAL ENERGY AUDIT REPORT

At your request, a Diagnostic Home Energy Survey was conducted on 12/15/2010. This report summary reflects the key findings and visual conditions at 33407 Buffalo Park Rd, Evergreen. This summary is not the complete Diagnostic Home Energy Survey report. There may be additional issues listed in the report that are not in this summary. The items are listed numerically in the order that they appear in the report and by priority. If you have any questions regarding your Diagnostic Home Energy Survey, please call us and we will gladly answer your questions. Thank you for choosing Colorado Professional Inspections/ECO-SPECT.

Address: 33407 Buffalo Park Rd  
Evergreen, CO

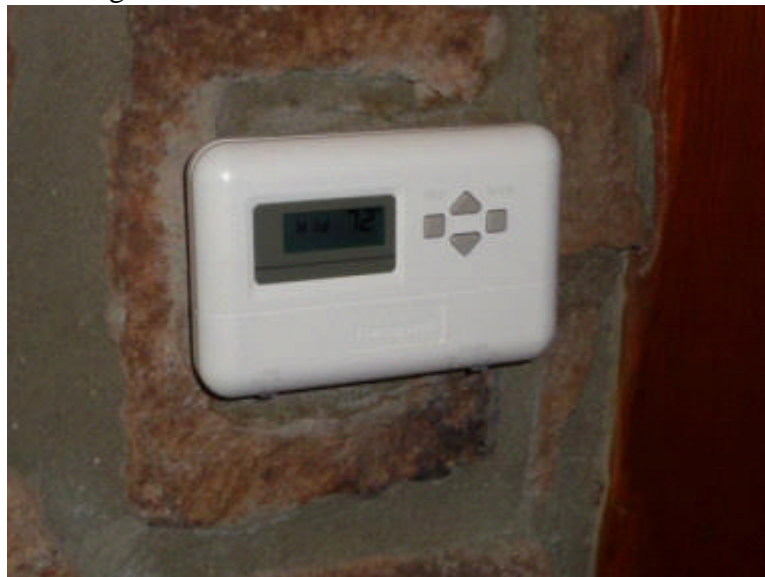
Night Time Setpoints:   The thermostats are set a steady temperature day and night.  
Efficiency Assessment:   **This item could be improved. Recommend upgrading.**  
Recommendations:     Set the programmable thermostat to reduce the temperature of the home at times when optimum comfort is not needed- like when you are sleeping or not at home.

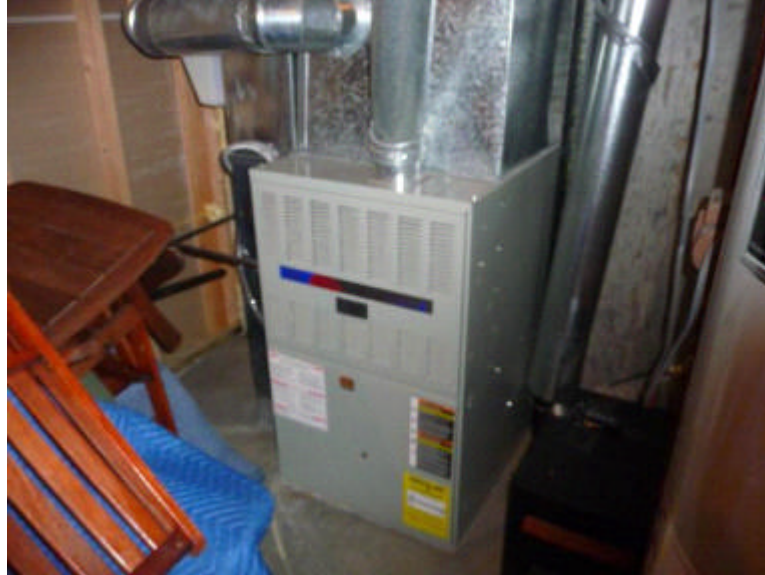
System Type: Twin Forced Air, Mid efficiency (79-83%).

Efficiency Assessment: **This item could be improved. Recommend upgrading.**

Recommendations: Your home has a large volume of conditioned space and high utility bills. Your main source of heating fuel is expensive propane (usually 2x more than natural gas). You live in a high altitude area which has more heating days than other areas in Colorado. Because of esthetic and comfort concerns with other energy conservation and efficiency measures, I recommend that you upgrade to a geothermal heat pump system to replace your existing heating and domestic hot water systems. Since geothermal systems are electric, I recommend that you power all or a portion of it with photo voltaic solar panels.

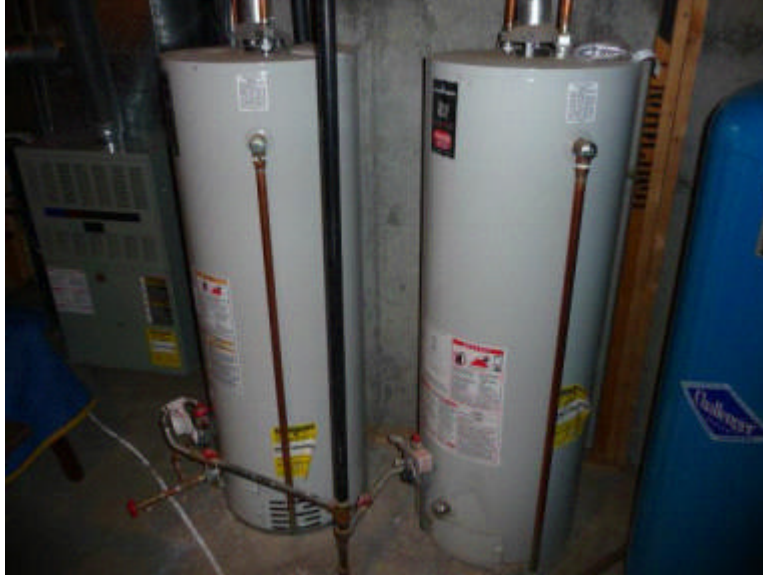
Type: 2xGas, atmospherically vented tank type.

Efficiency Assessment: **Poor performance or condition. This item is a priority upgrade.**

Recommendations: Recommend replace with a system that piggy backs onto a geothermal heating system. See heating system section for further info.

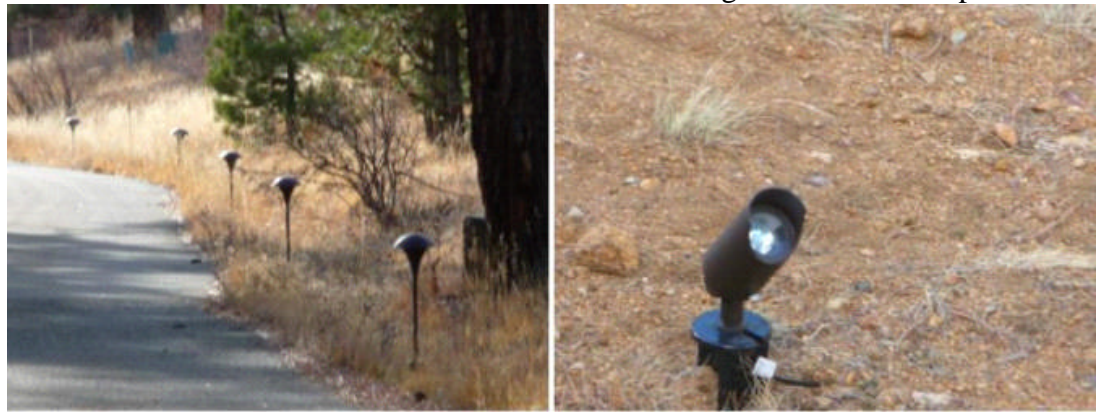
Outdoor Lighting: There is a significant amount of outdoor lighting on the property. Try to limit the on times for this type of lighting. Convert to LED bulbs where practical. Transformers and wiring for low voltage lighting waste energy. Convert low voltage to line voltage lighting where practical. Adjust timers seasonally to reduce on times. Make use of motion sensors and light sensors where practical.

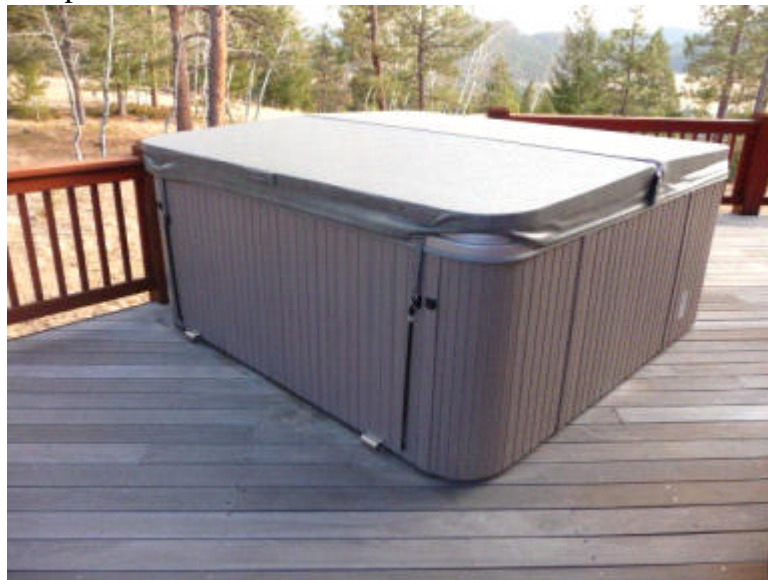
Efficiency Assessment: **Poor performance or condition. This item is a priority upgrade.**

Turndown or drain The hot tub when you are not using it regularly Your home has an exterior hot tub. Hot tubs are significant energy users. I recommend that you use them sparingly or not at all. When you are not using your tub for an extended period, you should winterize it and disconnect the power. I recommend that you offset this usage with solar voltaic panels or purchase wind power.

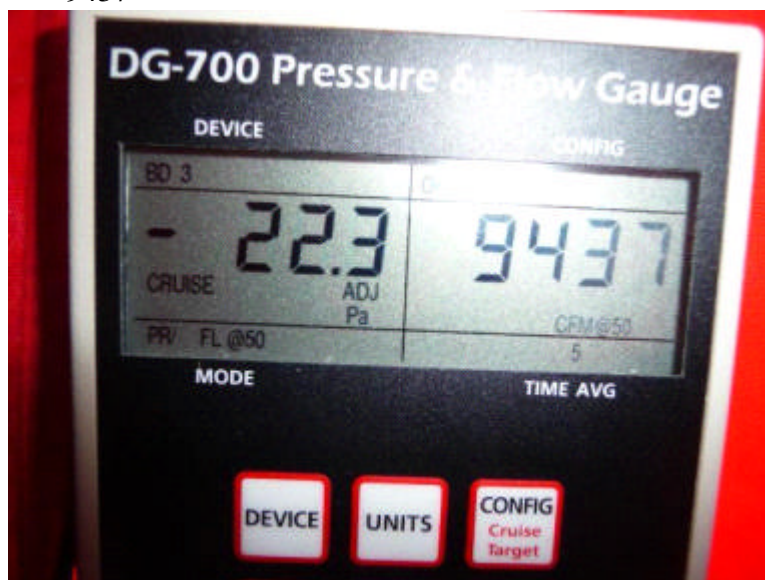
Notes: The house is so leaky and large that I couldn't reach a standard test pressure of -50p. The equipment reached its capacity at -22p. At that rate the "estimated" CFM/50 was: 9437.

Average Ceiling Height:	14
Approximate Cubic Feet:	70000
Number of Stories:	2
N Factor:	14.8
ACH:	8.09
NACH:	.55
Efficiency Assessment:	<b>Poor performance or condition. This item is a priority upgrade. See Air Sealing recommendations</b>

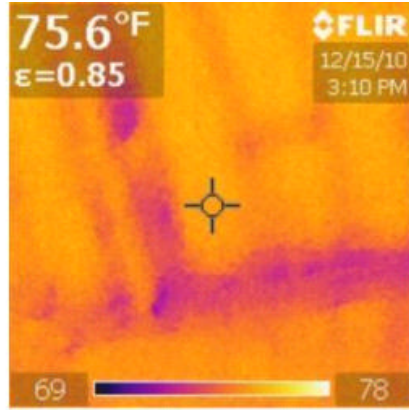
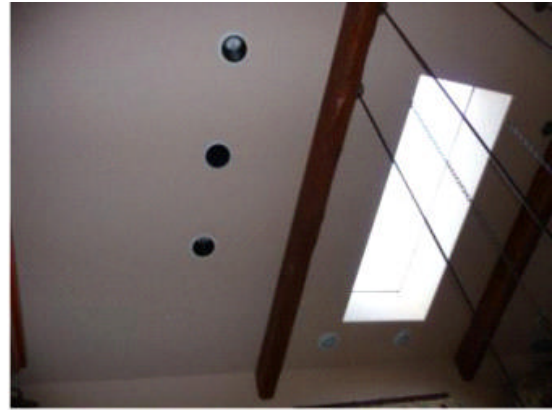
Image 1: Air leakage from recessed lights in kitchen.

Recessed Lighting - seal the recessed light fixtures in the home. Seal around the edges and any holes present when the trim and bulb are removed, with an appropriate fire rated caulking. For recessed lights that are accessible in the attic, build an insulating box using foil faced, rigid board insulation, place this over the can light, and caulk or seal the edges. Then you can move the insulation all around this box. Or install modern sealed recessed light cans.

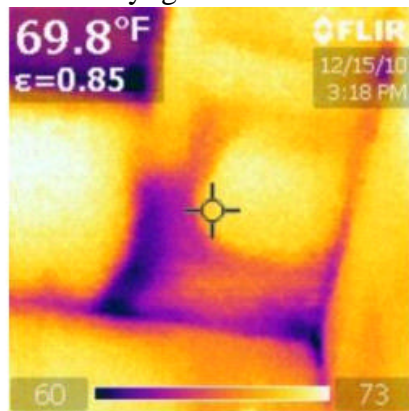
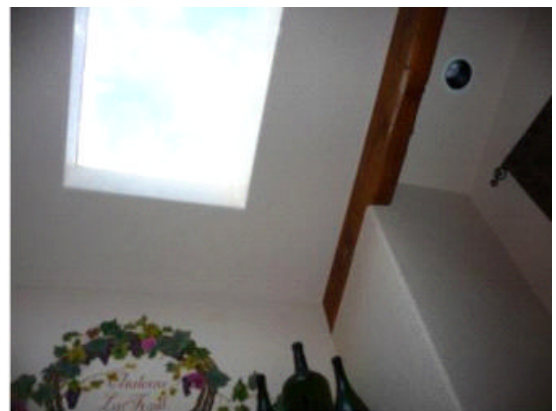
Image 2:

Poorly installed insulation is allowing air leakage and heat loss below the kitchen skylight

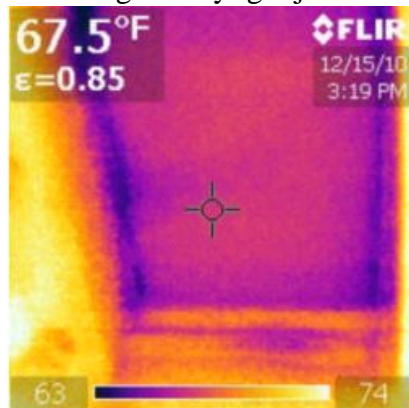
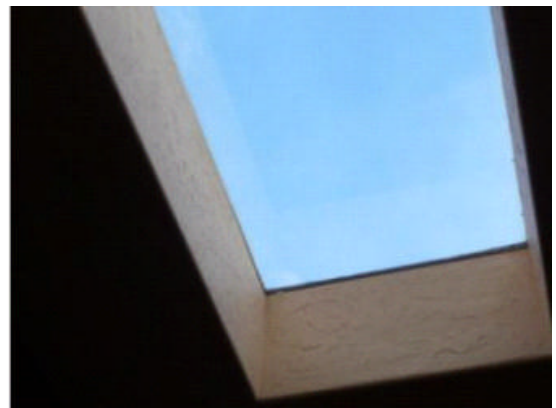
Image 3:

Air leakage at skylight jambs.

Type: The predominate skylight type is wood framed with double pane glass.  
Efficiency Assessment: Adequate performance. Not a priority upgrade.  
Observations: Functional. but leaky.  
Recommendations: Consider installing shades or blinds on the skylights. This will provide you with the ability to close off the skylights to prevent solar heat gains in the summer months and prevent heat loss in the winter night time hours. Caulk the jamb to drywall joint to reduce air leakage.

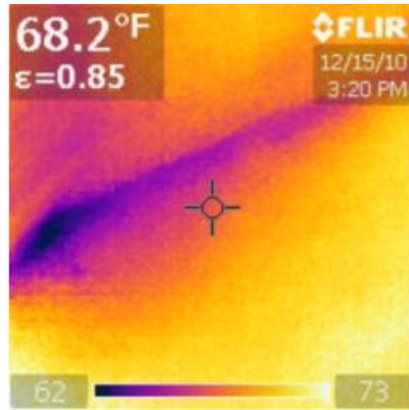
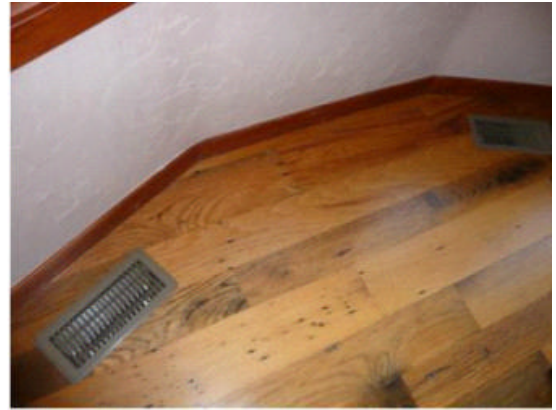
Image 4:

Rim joist air leakage , visible at baseboard trim in the dining area.

*Rim Joist:* The intersection of the main floor and joist header area is particularly susceptible to air leakage at the framing intersections, around service penetrations in the header areas, and at the basement ceiling where penetrations lead to the upper floors of the house or attic. Air leakage should also be controlled at the joint of the foundation and the sill plate, between the exterior sheathing and the sill plate, at the joint of the header and each joist, between the top of the header and the subfloor, from the basement into the header cavity through the open-face of the header area, and through subfloor cracks from the header cavity. Polyurethane caulk is often appropriate for this joint unless it is larger than 1/4 inch, in which case urethane foam is a good choice. The entire length of the joint between the sill plate and the top of the foundation wall

should be sealed.

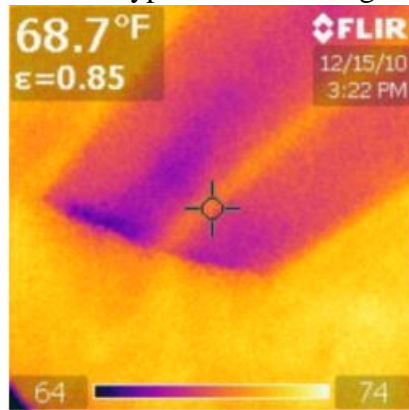
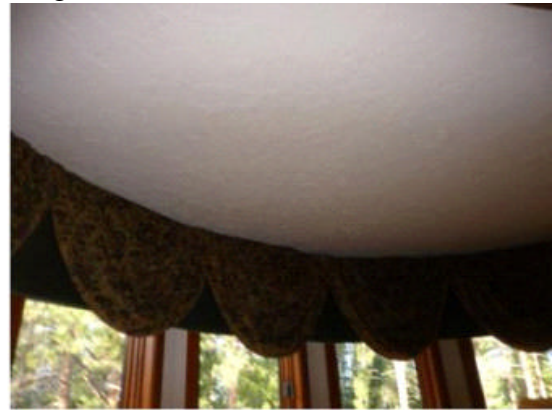
Image 5:

Thermal bypass in the ceiling of the dining area.

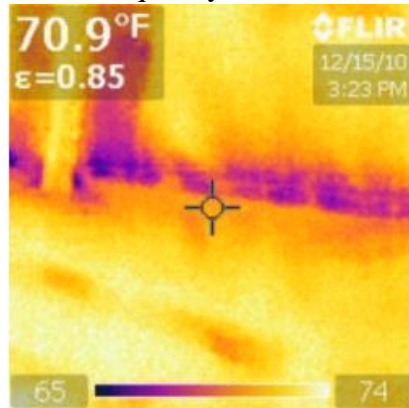
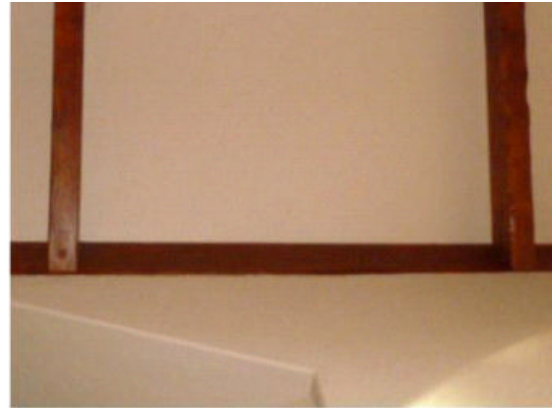
Image 6:

There is a lot of air leakage around the beams. The beams are not caulked and sealed adequately.
