PROFESSIONAL ENERGY AUDIT REPORT

Audit Company: **Colorado Professional Inspections/ECO-SPECT**

AUDIT SUMMARY

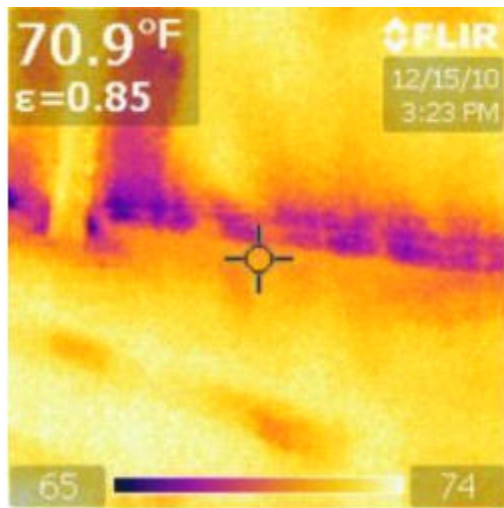
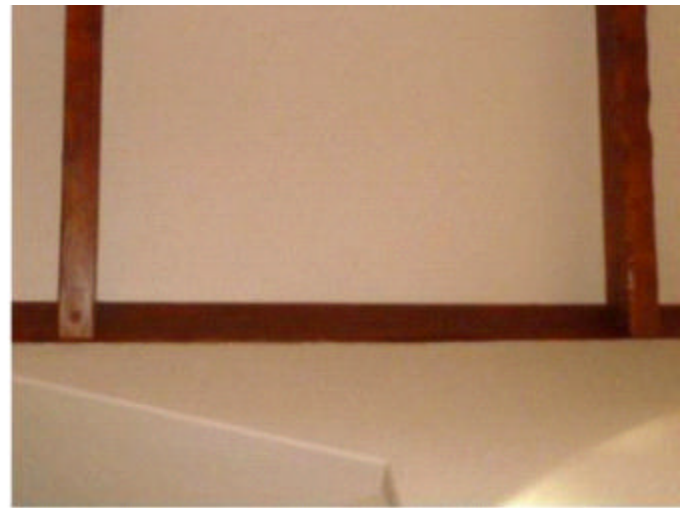
Image 6:

There is a lot of air leakage around the beams. The beams are not caulked and sealed adequately.

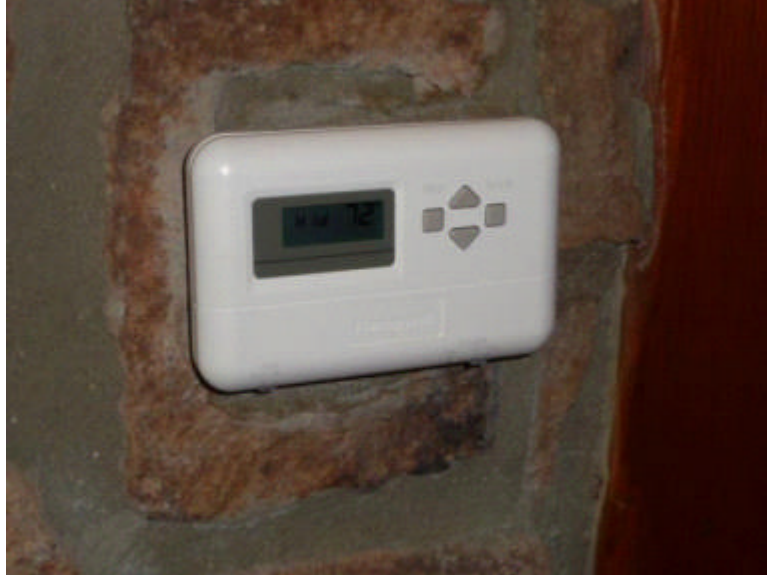
Night Time Setpoints: The thermostats are set a steady temperature day and night.

Efficiency Assessment: **This item could be improved. Recommend upgrading.**

Recommendations: Set the programmable thermostat to reduce the temperature of the home at times when optimum comfort is not needed- like when you are sleeping or not at home.

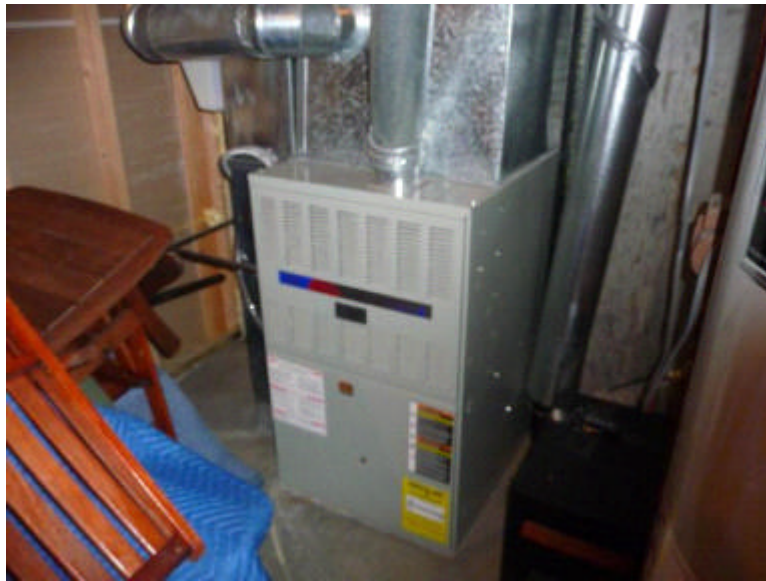
System Type: Twin Forced Air, Mid efficiency (79-83%).

Efficiency Assessment: **This item could be improved. Recommend upgrading.**

Recommendations: Your home has a large volume of conditioned space and high utility bills. Your main source of heating fuel is expensive propane (usually 2x more than natural gas). You live in a high altitude area which has more heating days than other areas in Colorado. Because of esthetic and comfort concerns with other energy conservation and efficiency measures, I recommend that you upgrade to a geothermal heat pump system to replace your existing heating and domestic hot water systems. Since geothermal systems are electric, I recommend that you power all or a portion of it with photo voltaic solar panels.

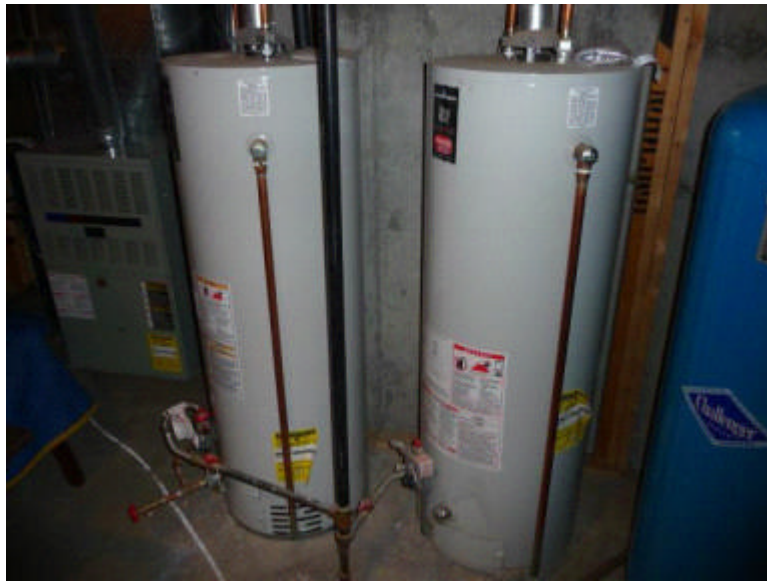
- Type: 2xGas, atmospherically vented tank type.

Efficiency Assessment: **Poor performance or condition. This item is a priority upgrade.**

Recommendations: Recommend replace with a system that piggy backs onto a geothermal heating system. See heating system section for further info.

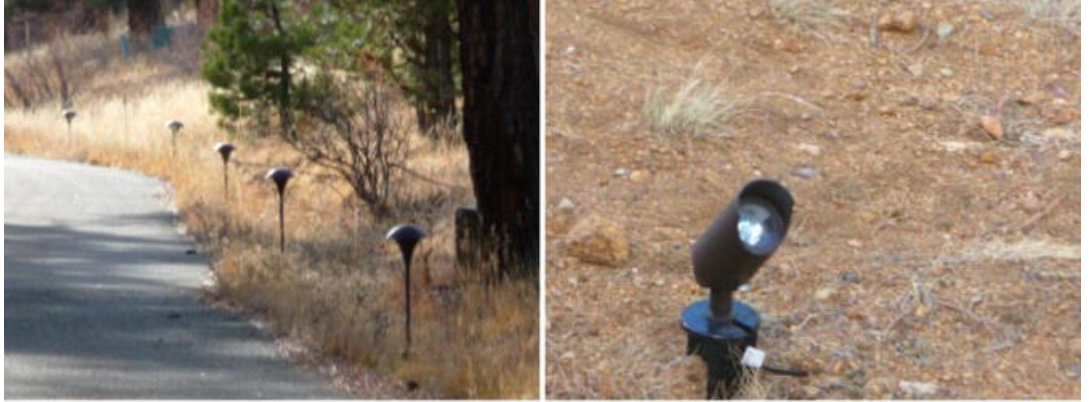
There is a significant amount of outdoor lighting on the property. Try to limit the on times for this type of lighting. Convert to LED bulbs where practical. Transformers and wiring for low voltage lighting waste energy. Convert low voltage to line voltage lighting where practical. Adjust timers seasonally to reduce on times. Make use of motion sensors and light sensors where practical.

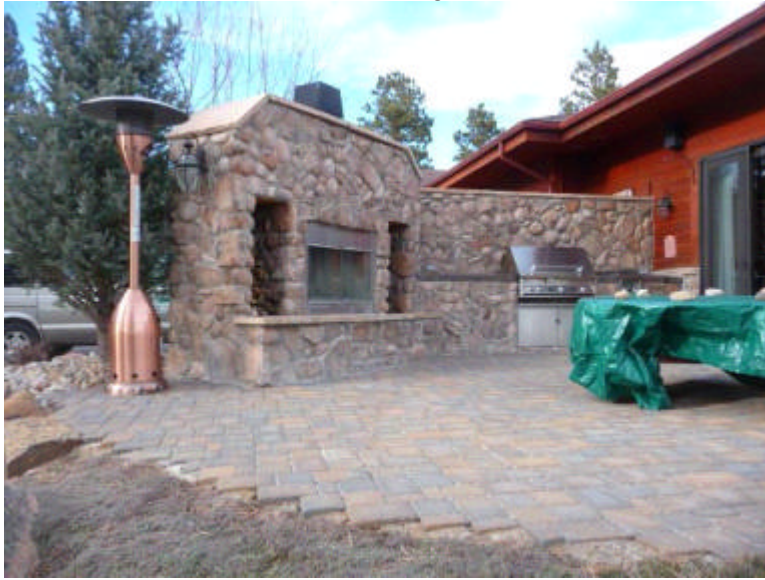
Have gas burning appliances and piping checked for leaks. Be sure that appliance are shut off and consider shutting valves off when not in use.

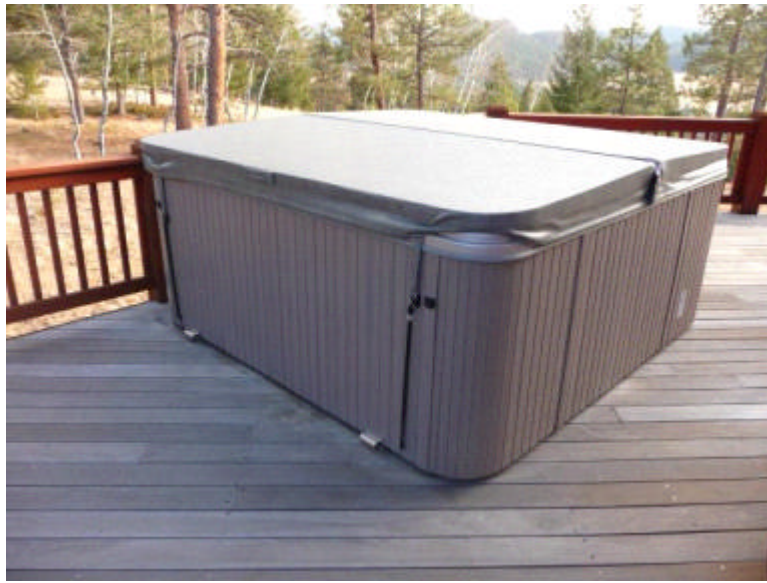
Efficiency Assessment: **Poor performance or condition. This item is a priority upgrade.**

Turndown or drain The hot tub when you are not using it regularly Your home has an exterior hot tub. Hot tubs are significant energy users. I recommend that you use them sparingly or not at all. When you are not using your tub for an extended period, you should winterize it and disconnect the power. I recommend that you offset this usage with solar voltaic panels or purchase wind power.

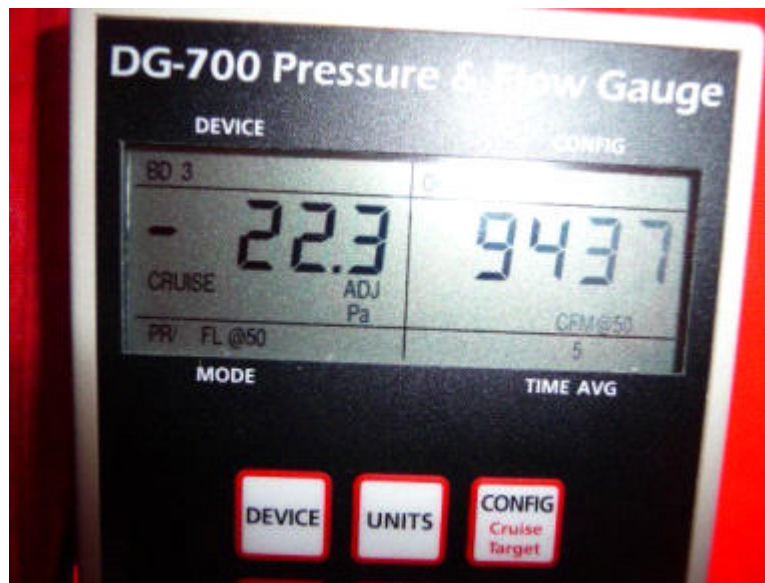
Notes: The house is so leaky and large that I couldn't reach a standard test pressure of -50p. The equipment reached its capacity at -22p. At that rate the "estimated" CFM/50 was: 9437.

ACH: 8.09

NACH: .55

Efficiency Assessment: **Poor performance or condition. This item is a priority upgrade.** See Air Sealing recommendations

Building Tightness: Your home has an NACH above .50. It would benefit from significant economic savings with general air sealing. See air sealing section for details.

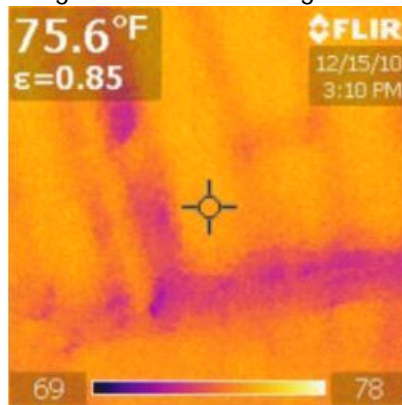
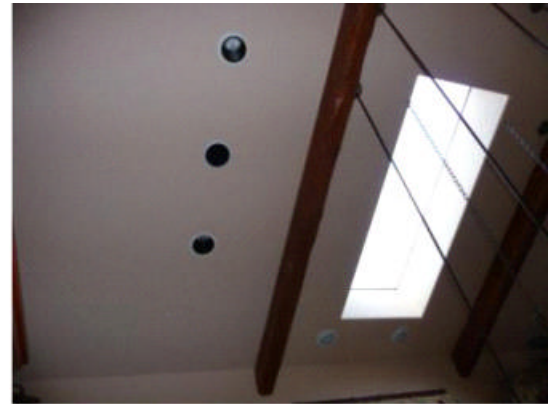
Image 1: Air leakage from recessed lights in kitchen.

Recessed Lighting - seal the recessed light fixtures in the home. Seal around the edges and any holes present when the trim and bulb are removed, with an appropriate fire rated caulking. For recessed lights that are accessible in the attic, build an insulating box using foil faced, rigid board insulation, place this over the can light, and caulk or seal the edges. Then you can move the insulation all around this box. Or install modern sealed recessed light cans.

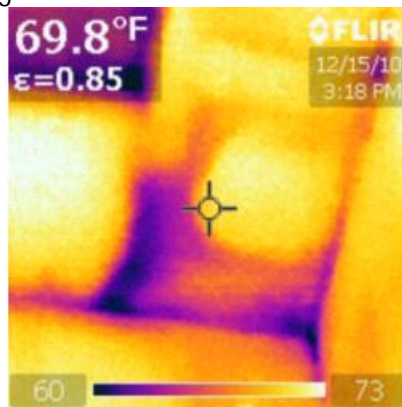
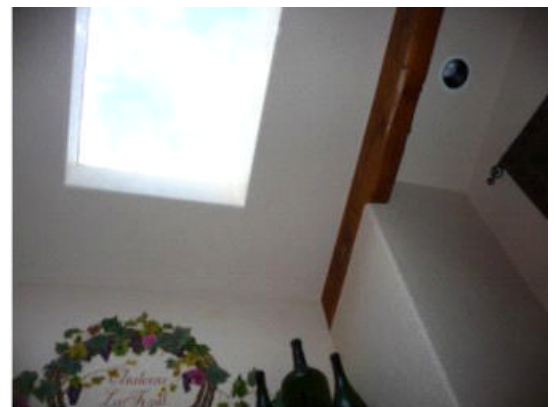
Image 2: Poorly installed insulation is allowing air leakage and heat loss below the kitchen skylight

Recommendations: Recommend additional insulation in the ceiling for better energy efficiency. Although the ceiling insulation levels in the visible areas appear to meet minimum requirements of R-30., I recommend increasing insulation levels to R-54 in your area.

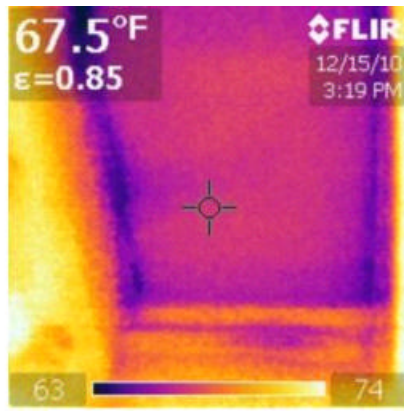
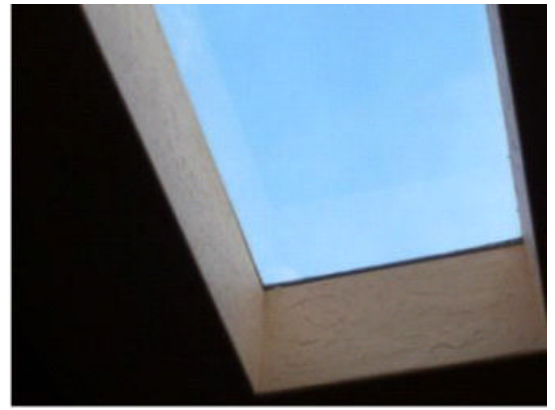
Image 3: Air leakage at skylight jambs.

Recommendations: Consider installing shades or blinds on the skylights. This will provide you with the ability to close off the skylights to prevent solar heat gains in the summer months and prevent heat loss in the winter night time hours. Caulk the jamb to drywall joint to reduce air leakage.

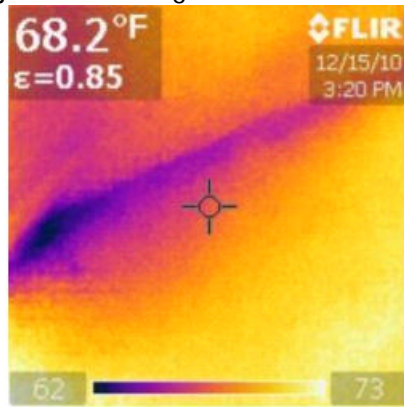
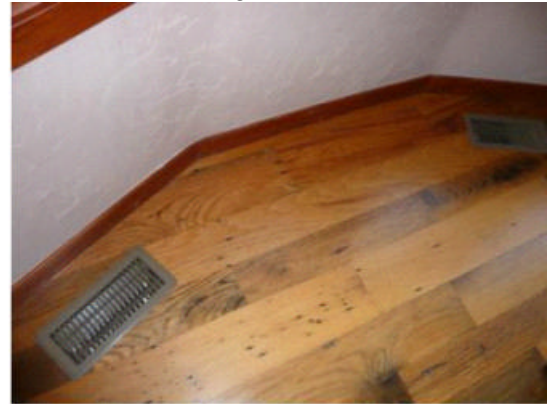
Image 4:

Rim joist air leakage , visible at baseboard trim in the dining area.

Rim Joist: The intersection of the main floor and joist header area is particularly susceptible to air leakage at the framing intersections, around service penetrations in the header areas, and at the basement ceiling where penetrations lead to the upper floors of the house or attic. Air leakage should also be controlled at the joint of the foundation and the sill plate, between the exterior sheathing and the sill plate, at the joint of the header and each joist, between the top of the header and the subfloor, from the basement into the header cavity through the open-face of the header area, and through subfloor cracks from the header cavity. Polyurethane caulk is often appropriate for this joint unless it is larger than 1/4 inch, in which case urethane foam is a good choice. The entire length of the joint between the sill plate and the top of the foundation wall should be sealed.

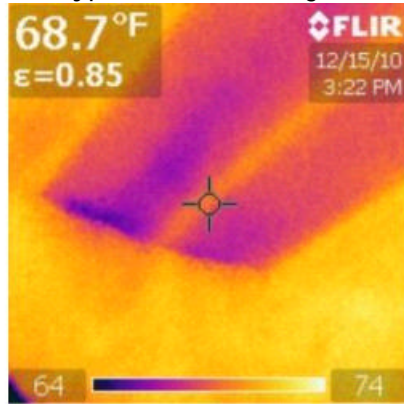
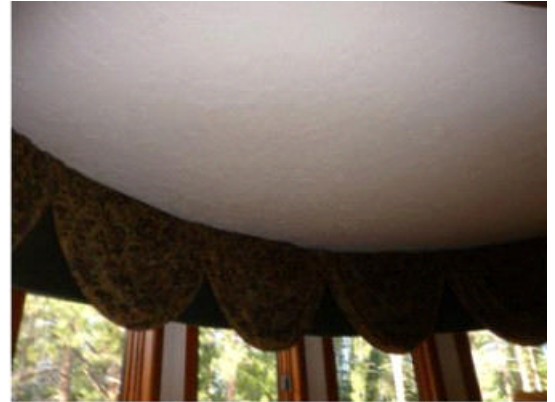
Image 5:

Thermal bypass in the ceiling of the dining area.

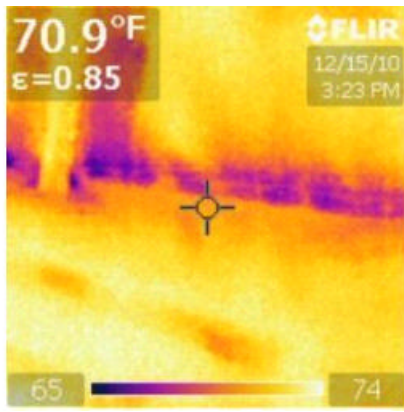
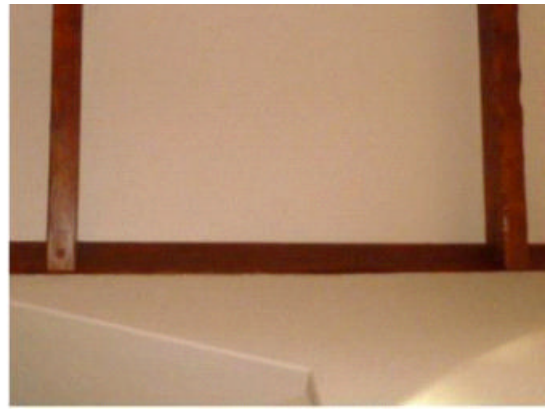
Image 6:

There is a lot of air leakage around the beams. The beams are not caulked and sealed adequately.

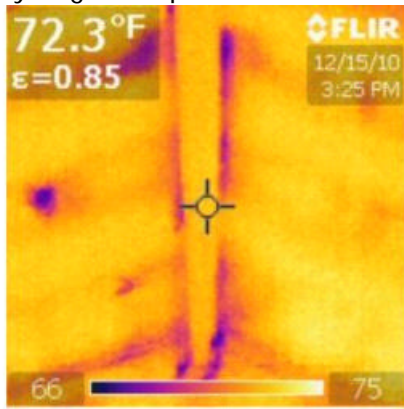
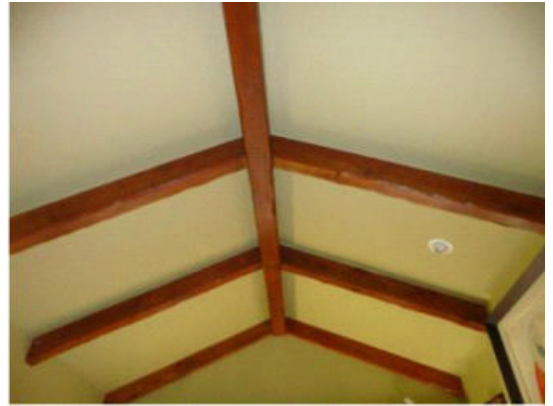
Image 7:

Well, you get the picture.
