PROFESSIONAL INSPECTION REPORT

Subject Property: Your next Home
Loveland, CO

Inspector: Bruce Czech
Building Consultant/Master Inspector
ASHI® Certified Inspector # 207435
Certified RESNET Energy Rater # 298
Member, Historic Building Inspectors Association

Colorado Professional Inspections

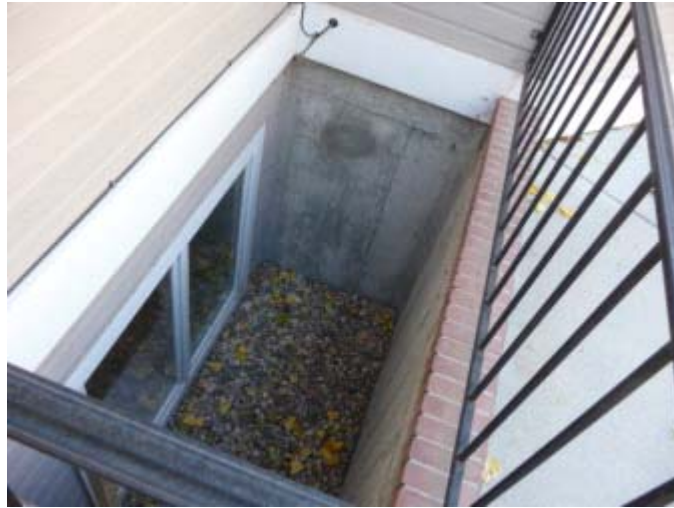
Slope Description: Moderate.
General Condition: Functional.
Comments: The drains were not found for the window bulkhead at the rear of the house.

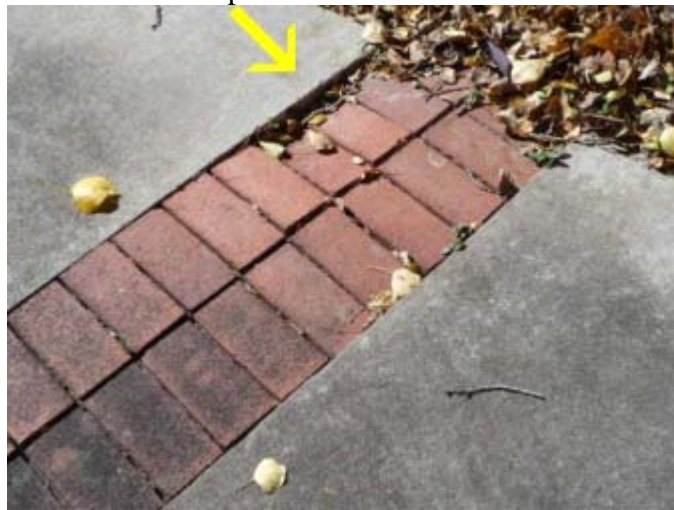
There is a trip had on the sidewalk in from of the front door.

Condition Details: There is a trip had on the sidewalk in from of the front door.

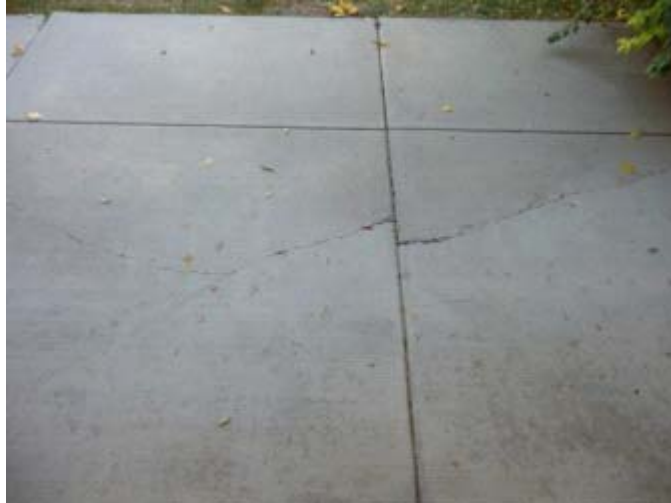
There were some cracks in the back patio slab.

Condition Details: There were some cracks in the back patio slab.

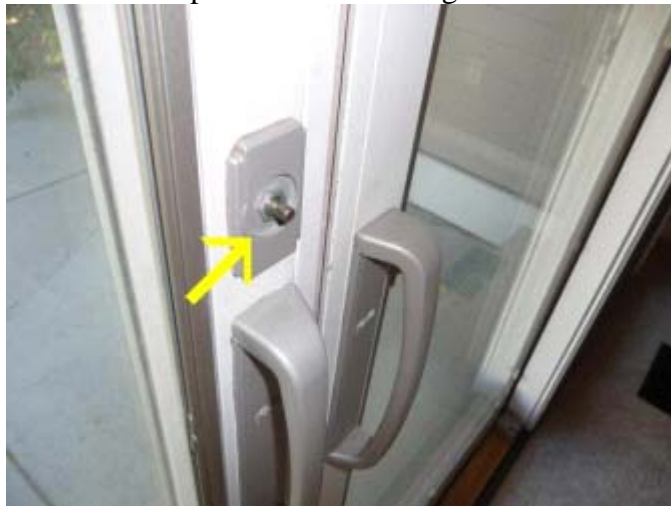
The back patio door is missing the lock lever.

Condition Details: The back patio door is missing the lock lever.

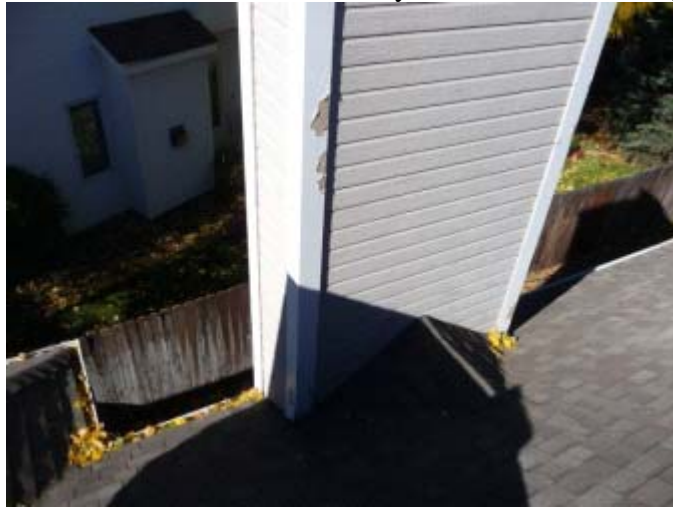
Some areas of the chimney trim need refinishing and repair.

Condition Details: Some areas of the chimney trim need refinishing and repair.

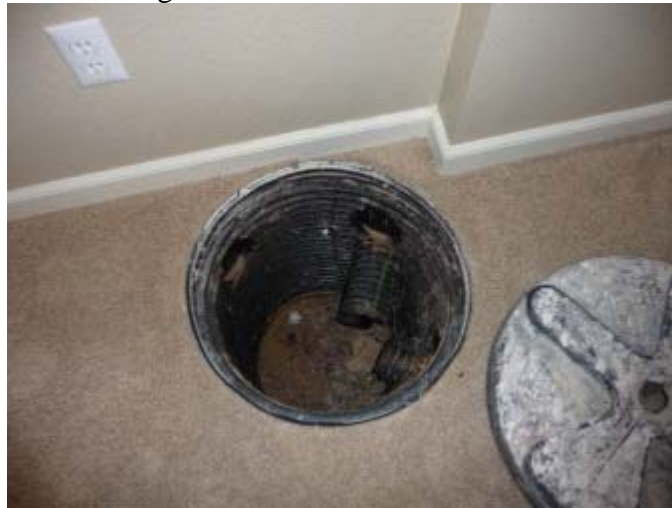
There is a sump pit in the bedroom closet but there is no sump pump installed. I recommend that a sump pump be installed to protect the basement from flooding.

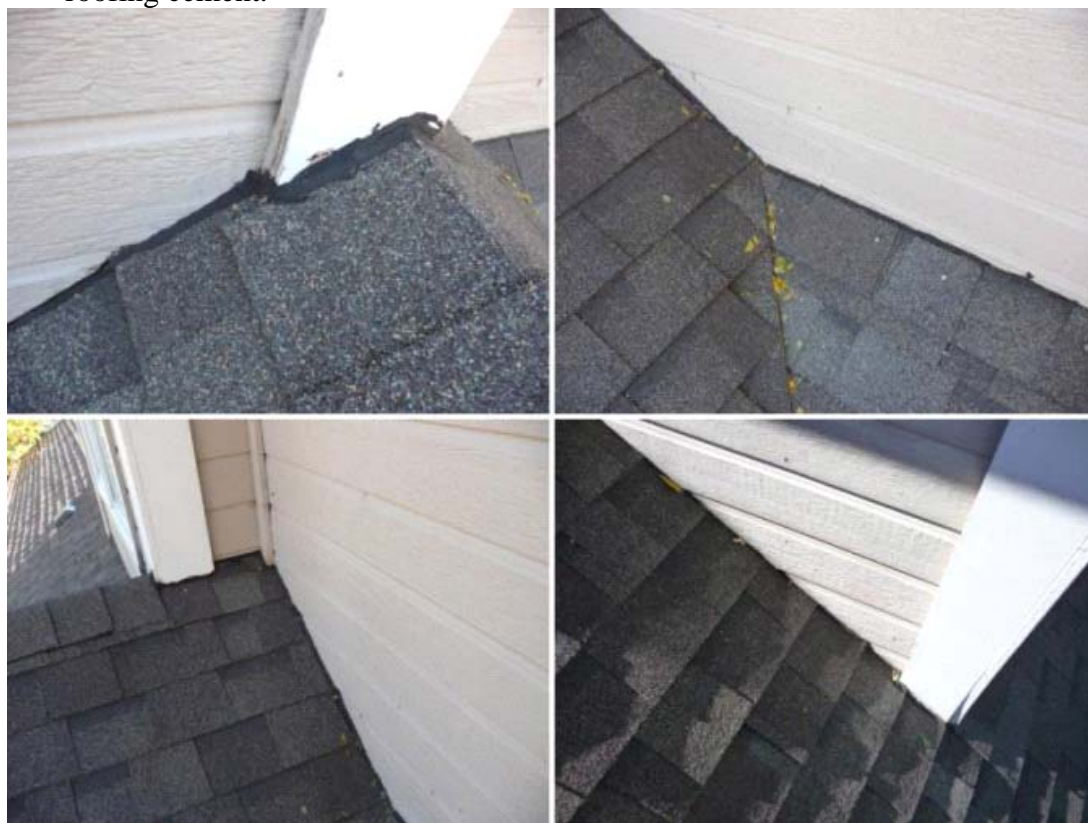
Some areas of the flashings at the back of the house have been sealed with roofing cement.

Condition Details: The dormer on the left side of the roof is improperly drained on the left side and may leak under some circumstances.

Comment: Some areas of the flashings at the back of the house have been sealed with roofing cement.

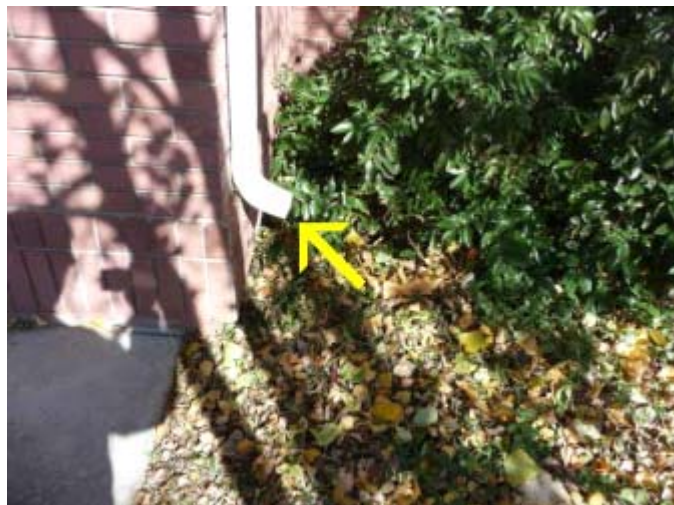
Condition Details: Repair or add downspout extensions, where necessary or missing, to direct roof drainage water way from the building and lessen the possibility of water intrusion into the basement or crawlspace.

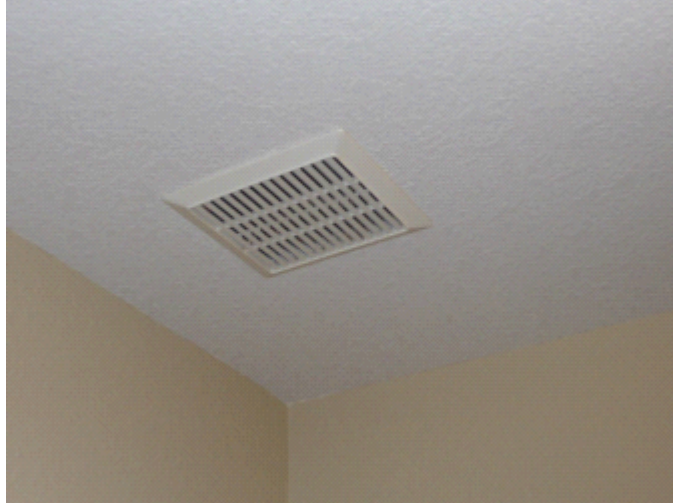
The bath vent fan doesn't work at the upstairs hall bath room. There is a leak under the vanity at the upstairs bathroom. The cold water stop valve leaks at the Rt. hand sink in the master bathroom.

Condition Details: The bath vent fan doesn't work at the upstairs hall bath room. There is a leak under the vanity at the upstairs bathroom. The cold water stop valve leaks at the Rt. hand sink in the master bathroom.

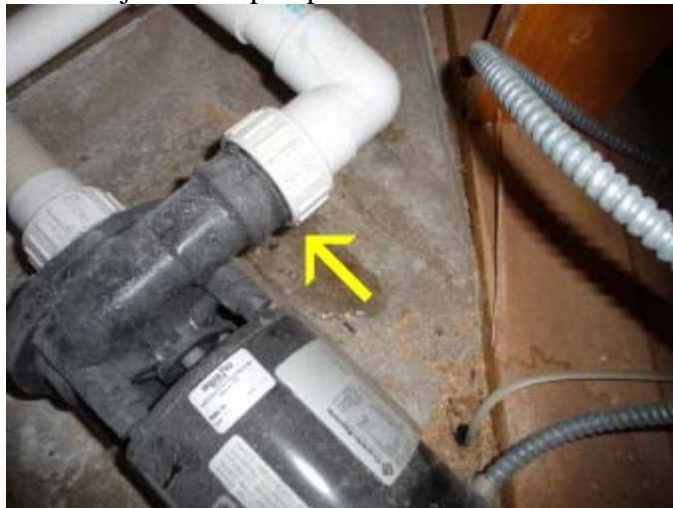
The jetted tub pump leaks at the inlet. The Jetted tub needs sanitizing.

Defects: The jetted tub pump leaks at the inlet. The Jetted tub needs sanitizing.
