PROFESSIONAL ENERGY AUDIT REPORT

Audit Company: **Colorado Professional Inspections/ECO-SPECT**

AUDIT SUMMARY

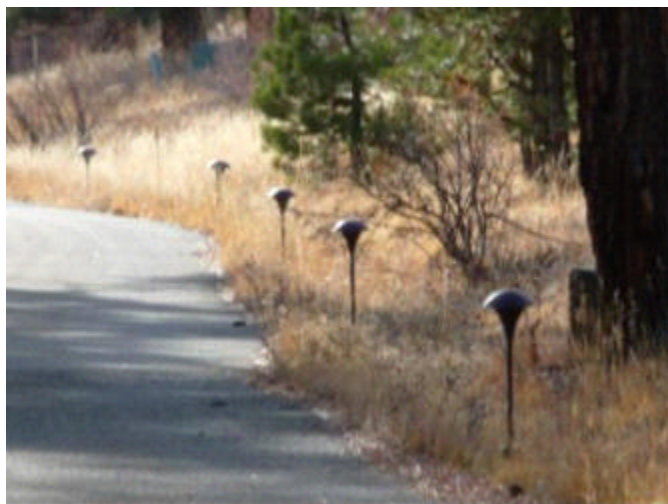
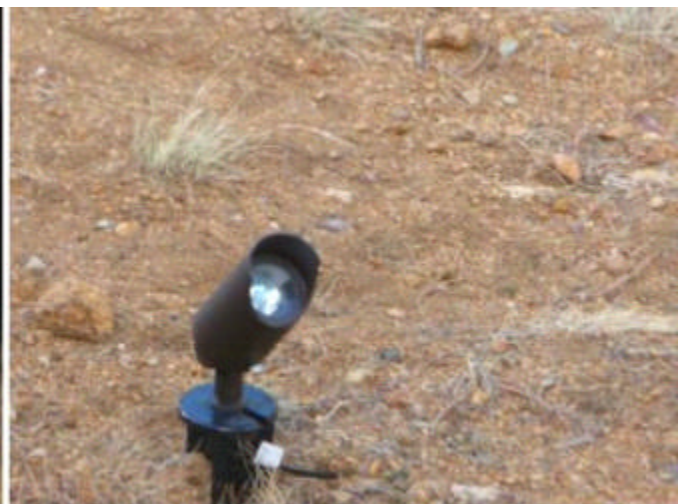
Outdoor Lighting:

There is a significant amount of outdoor lighting on the property. Try to limit the on times for this type of lighting. Convert to LED bulbs where practical. Transformers and wiring for low voltage lighting waste energy. Convert low voltage to line voltage lighting where practical. Adjust timers seasonally to reduce on times. Make use of motion sensors and light sensors where practical.

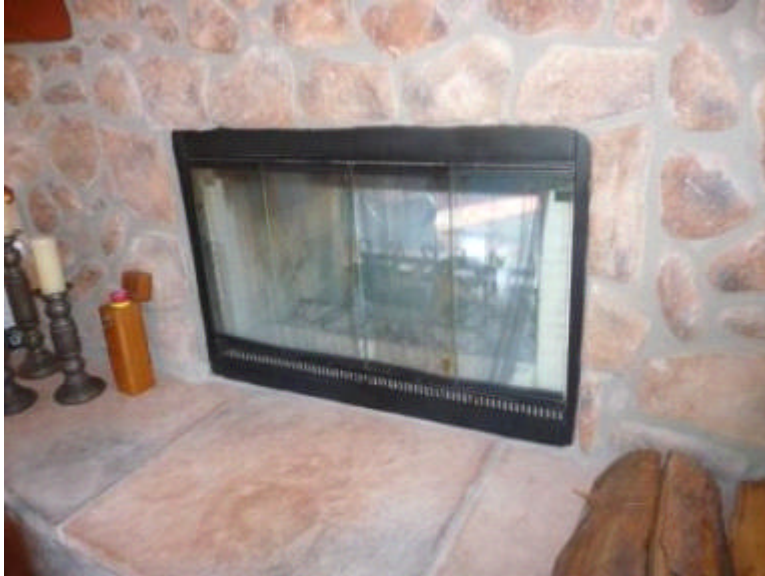
Fireplace/Wood Stove

- Type: Gas fired, sealed combustion. Prefabricated, gas log type.
- Efficiency Assessment: Adequate performance. Not a priority upgrade.
- Recommendations: Close the damper on the wood burning fireplace when it is not in use- to reduce air leakage in the home.

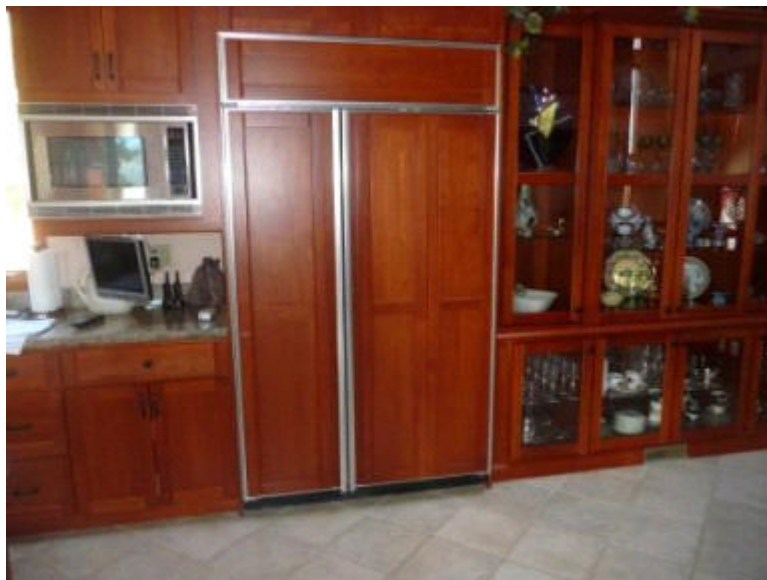
Refrigerator

Estimated Age: 10

Efficiency Assessment: Adequate performance. Not a priority upgrade.

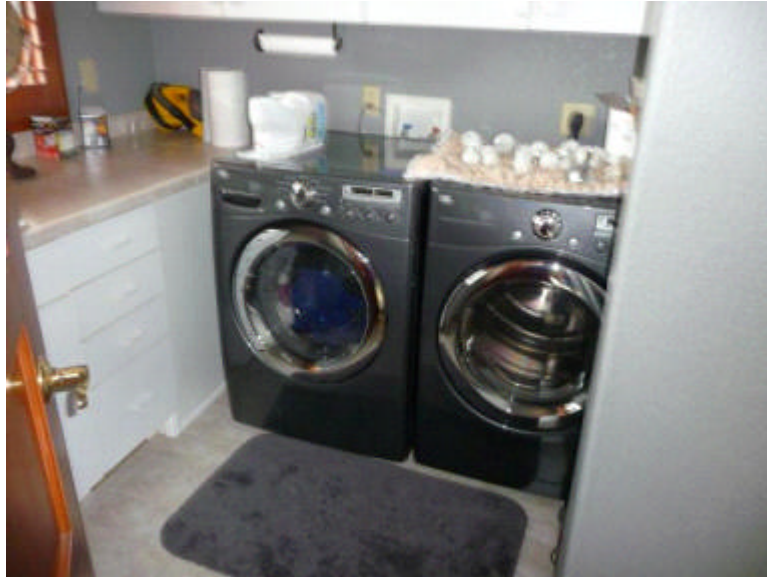
Washing Machine

Type: Front Loader.

Efficiency Assessment: Excellent! High performance.
