PROFESSIONAL INSPECTION REPORT

Subject Property: Your next Home
Loveland, CO

Inspector: Bruce Czech
Building Consultant/Master Inspector
ASHI® Certified Inspector # 207435
Certified RESNET Energy Rater # 298
Member, Historic Building Inspectors Association

Colorado Professional Inspections

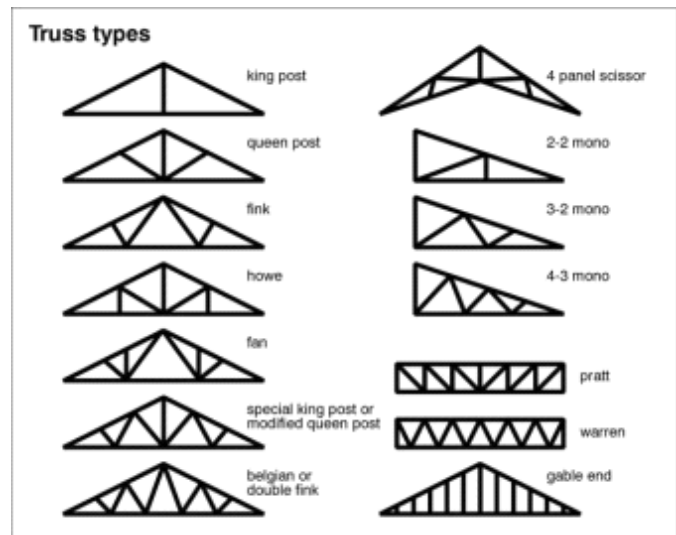
Roof Framing:

The roof framing is factory built, engineered trusses.

Roof decking: OSB or Plywood.

General Condition: Functional.

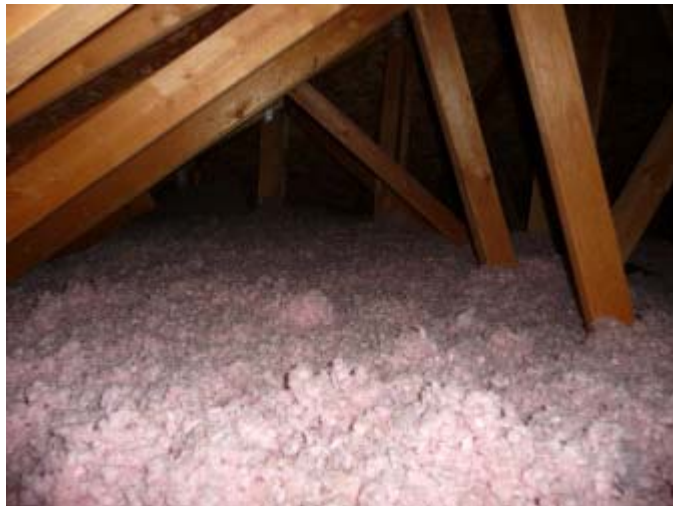
Attic Photo:

Predominate Insulation Type: Blown in fiberglass.

Depth: 12 inches.

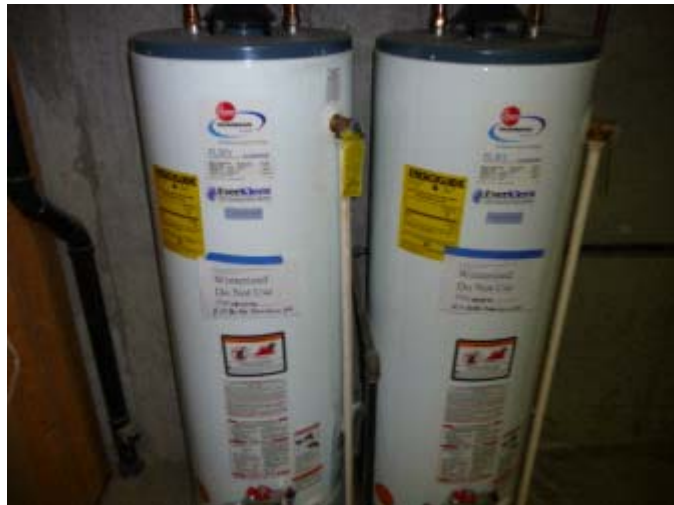
Water Heater

Type: Gas storage tank.
Equipment Photo:

Size: 40 X2 Gallons.
Manufacturer: Rheem.
Location: In the basement, next to the furnace.
Approx. Age: 1-5.
General Condition: Functional.
